RECORD OF DEFECTS ARISING IN MAJOR WORKS

Recorded by Leaseholders in  
Brighton and Hove City Council Property

Carried out under the Term Contract with Messrs. Mears  
between 2010 and 2020

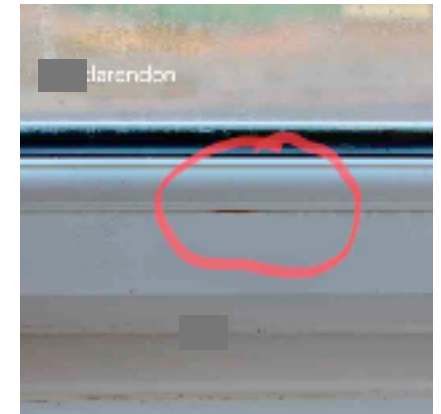
Top row:  
Shows water has seeped out past the glass and started to form black mould

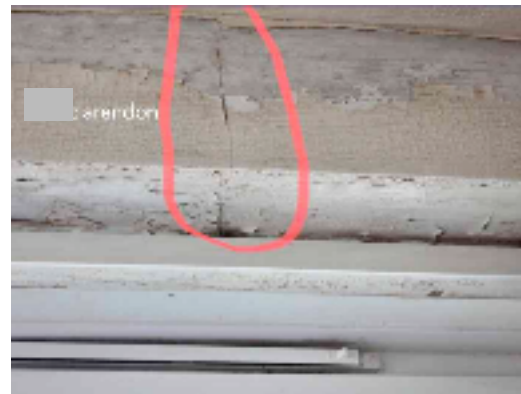
Bottom left:: unidentified: crack in concrete repair over window head

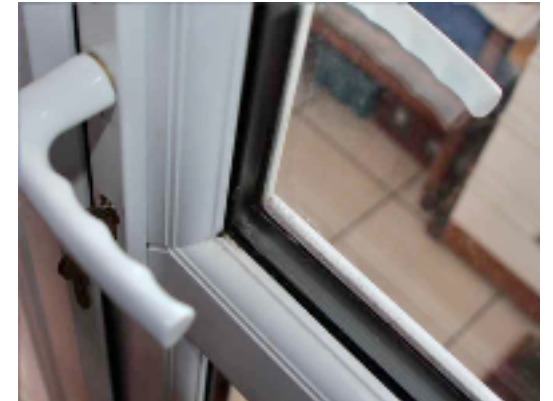
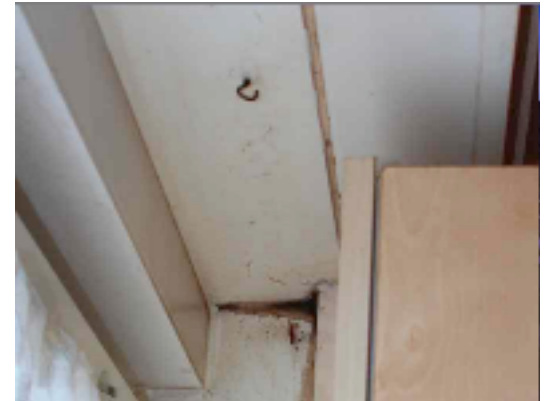
Top two rows are from a tenants flat next to the north lift top floor. More of the same problems.

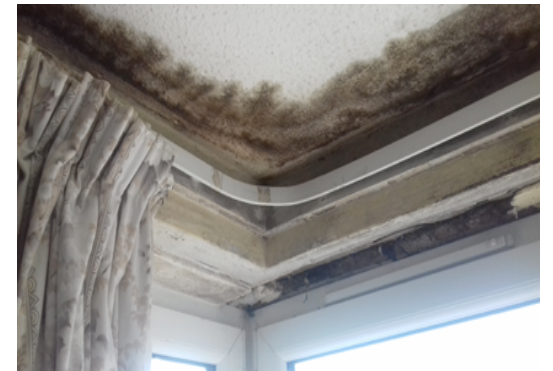
Photos showing severe damp over head of windows

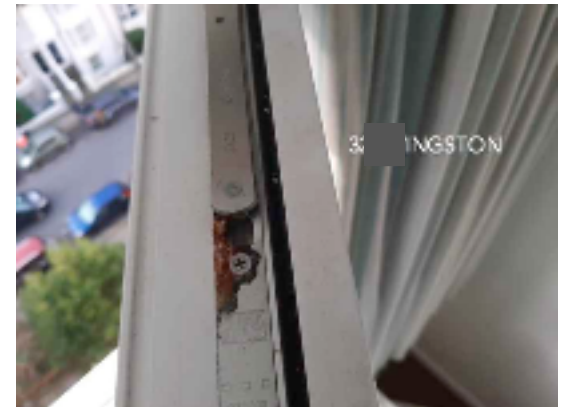
Centre left: windows are running out by 12mm and covering the drip channel  
Centre right: corrosion of ironmongery in window head due to leaking.

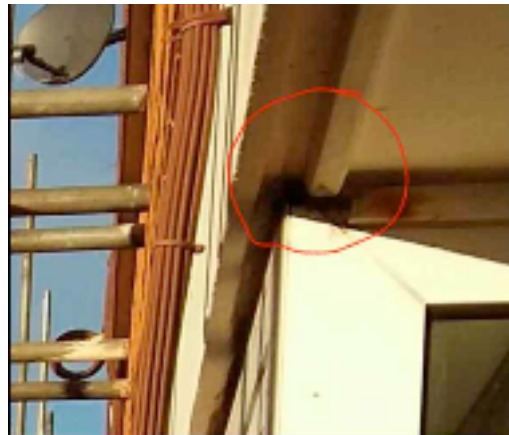
Bottom left:  
Photo of the old windows showing the drip channel at the top

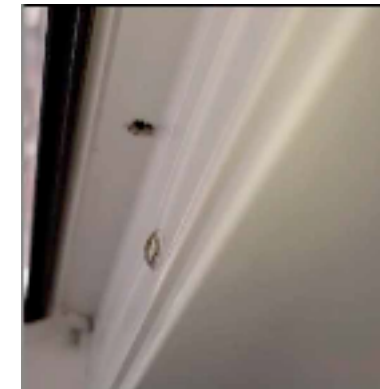
Bottom right:  
Shows water running out of screw hole

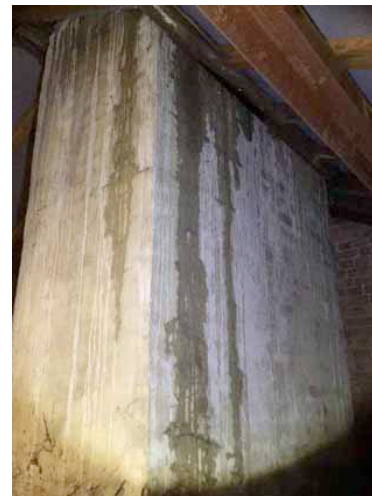
- leak on the chimney stack still outstanding - water coming through onto lounge ceiling, a faint watermark along a joint line 40cm from the chimney face and evidence of water on the back of the plasterboard

- insufficient flashing on chimney, gaping lead flashings and some old and missing pointing (pictures attached)
- the north chimney flashing is now leaking on three sides.

Top: leaking affecting adjacent ceiling as evident in roof void  
Centre: general external view of chimney  
Bottom: details of flashing

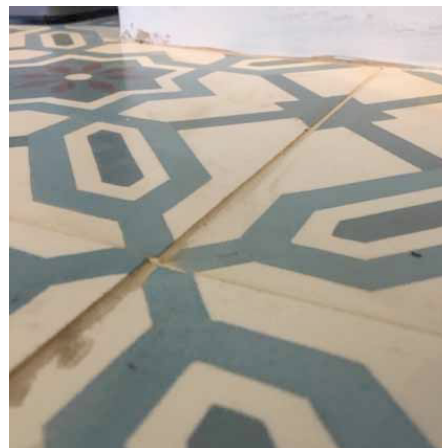
Bottom: damage to internal floor finish from leak following roofing works.

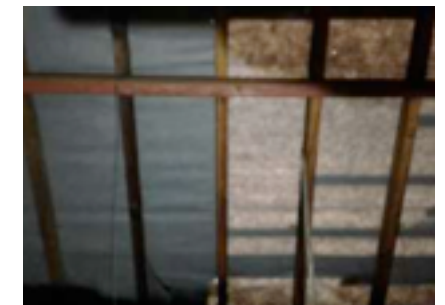
The Willows: Examples of defects  
 Top: ceiling damaged by roofer  
 Visible gap in chimney flashing  
 Vent pipe replaced where penetrating roof but existing hole not repaired  
 Centre: poor workmanship: sundry leaks, incomplete lining to roof  
 Bottom: leaking replacement downpipes, possibly undersized, and displaced leak guard  
 Unfixed and poorly installed soffit

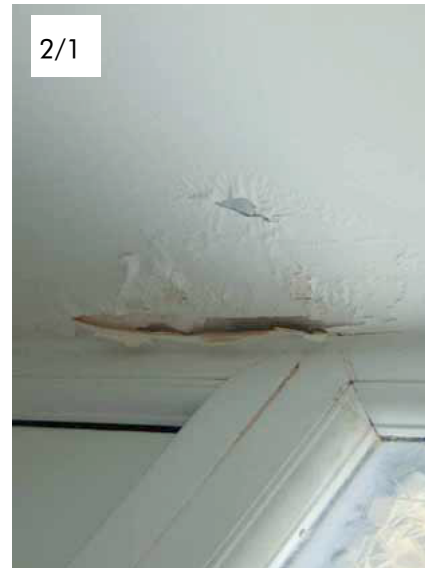
1/1: Malfunctioning restrictors

1/2 Latches not fully closing

2/1 Condensation or damp penetration

2/2 Water ingress due to faulty seal

2/3 Inaccessible fan control, affecting ventilation and encouraging condensation.

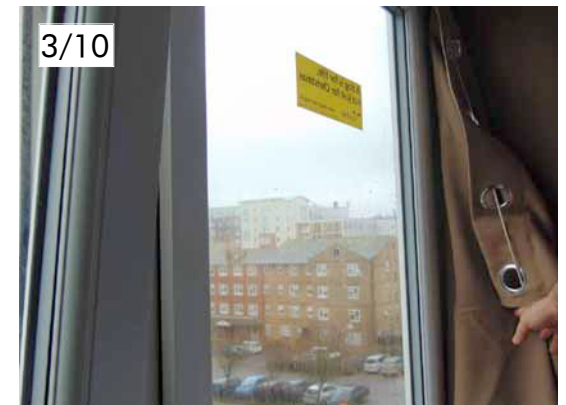
Sundry defects, ventilators, blinds etc.

3/4: Leaking at head of window and jamb

3/7: Dislodged gasket internally

3/6: Defective installation of blind

3/7: Mortar stains on glass, labels not removed
