# Hove Cemetery North Stock Condition Survey of Building Shell

To be read in conjunction with report for  
Proposed Accessible WC

Hove Cemetery North – Stock Condition Survey to Building Shell of WC Block.

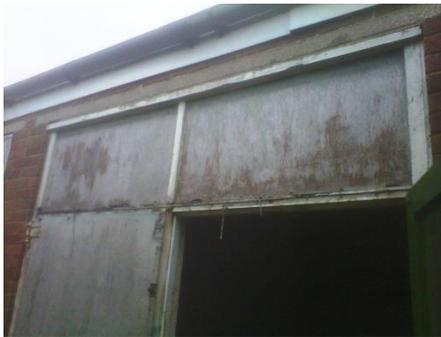
The roof requires minor works around fascias and gutters. Full renewal of felt roofing should not be necessary for approximately 5 years, if free of vandalism.

Dilapidated framing and dislodged fascia.

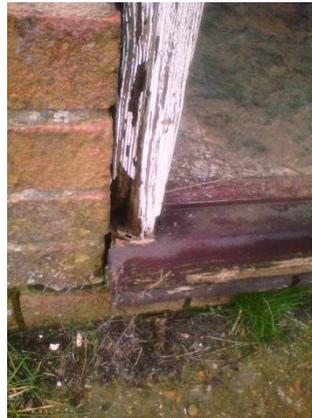
External doors are in only fair condition with rot to framing. The double doors to the store close against a centre post limiting the size of equipment that can be taken inside.

Rotted door post.

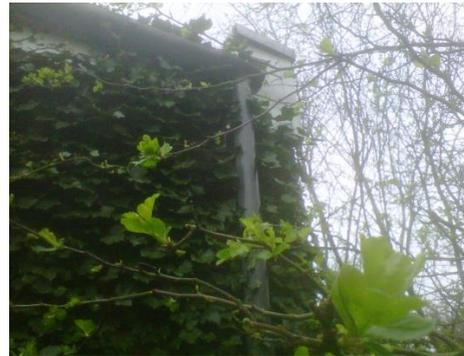
Vegetation around rainwater Goods.

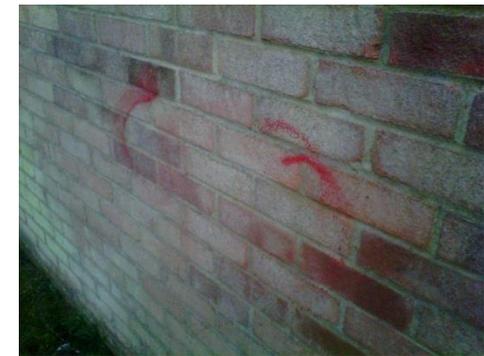
Example of graffiti.
