## TECHNICAL NOTE

**Job Name:** Seven Dials Junction Improvements, Brighton  
**Job No:** 21810/015  
**Note No:** TN004 rev A  
**Date:** 13<sup>th</sup> March 2013  
**Prepared By:** K. Marshall  
**Subject:** Conditions around the Elm Tree on Vernon Terrace

### Elm Tree on Vernon Terrace

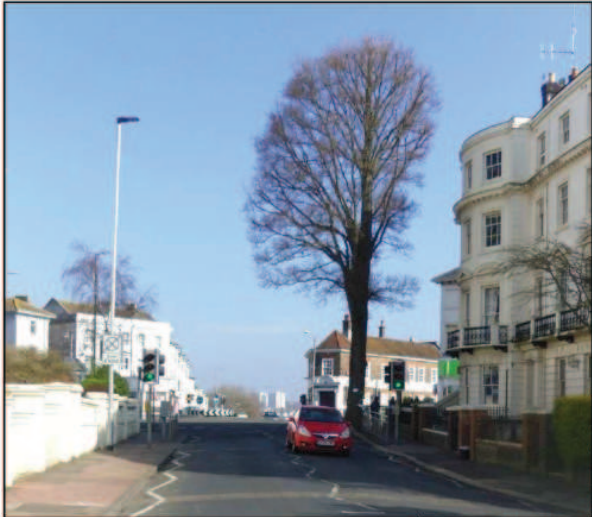
*Location Plan*

An existing Elm tree is situated in the southern footway of Vernon Terrace which is on the exiting arm travelling south-west from the Seven Dials roundabout in Brighton.

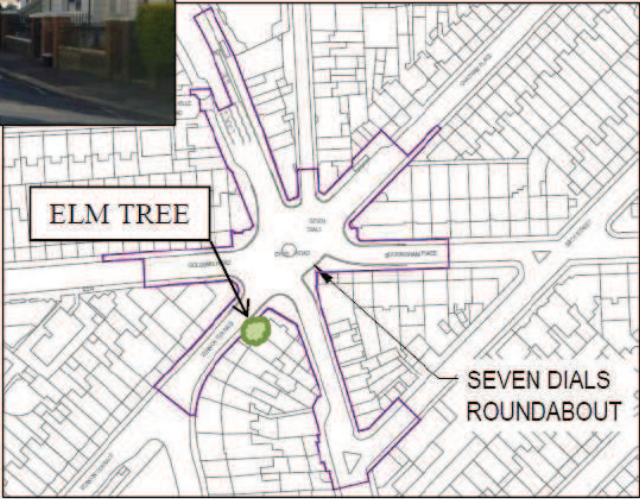
The tree is approximately 12 to 14m tall with a trunk approximately 1.0m wide and a canopy/root spread of approximately 8m. The tree appears to lean slightly southward towards the buildings on Vernon Terrace and there is evidence in the form of cracks and displacement of kerbs to show that the tree roots spread through the footway and out into the carriageway. It is reported that the tree roots also appear to be affecting the boundary wall of the adjacent property.

*Existing tree March 2013  
(from Vernon Terrace looking north-east)*

A new zebra crossing is proposed to be installed in approximately the same position as the existing pelican crossing. Therefore the above visibility issues also exist with the proposals, and are compounded by the removal of traffic signal control as the zebra crossing will rely more on forward visibility between pedestrians and vehicles to ensure the appropriate priorities are able to be given. It is therefore considered an essential part of the current zebra crossing design that the Elm tree is removed.

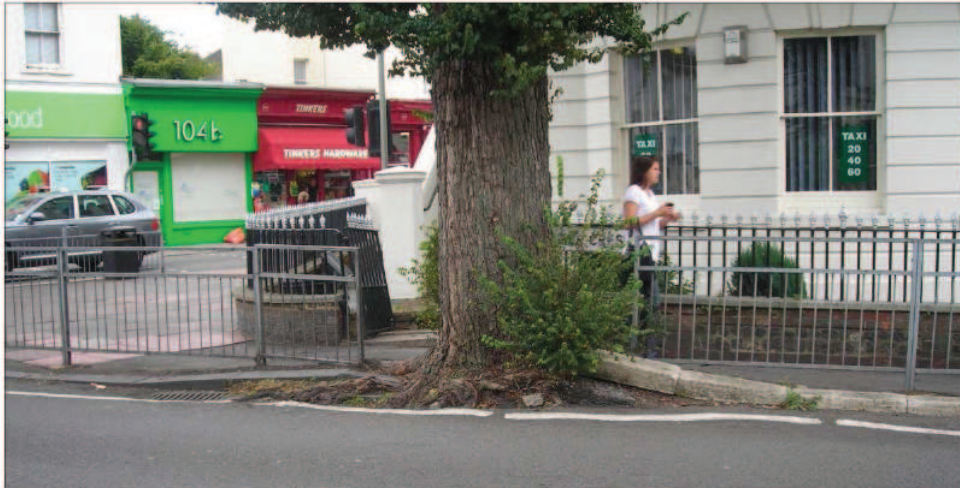
The existing position of the tree is such that it is interrupting the existing kerb line and pedestrian guard railing. Consequently the tree extends significantly into the carriageway as well as narrowing the footway.

*Existing carriageway and footway have been displaced / adjusted to suit the growth of the tree*

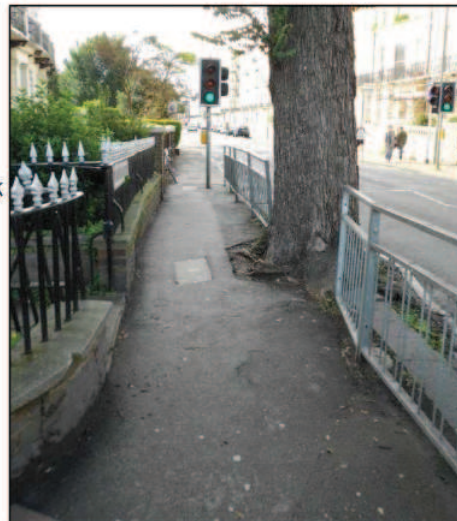
The existing footway width directly adjacent to the Elm has been measured on site as 0.95m wide. The footway has a crossfall from the tree to the back of the footway as a result of the tree roots pushing the footway surface upwards, the reverse of a normal situation. The existing footway either side of the tree is 2.0m wide and falls from the back of the footway to the carriageway.

*Footway width below standard 2.0m*

For the situation on Vernon Terrace the footway should therefore be a minimum of 2.0m wide and the existing situation is a departure from standard due to the Elm tree, particularly for blind and visually impaired people being guided. It is noted that the obstacle is over a short distance so ambulant pedestrians can 'give way' to one another. The route could be considered uncomfortable for the visually impaired and opposing wheelchair / pushchair users, although it is noted that opposing wheelchair users could 'give way' to each other. Given that one of the aims of the scheme is to improve the pedestrian environment, a sub-standard footway width is not a desired option.

1. There can be a full unobstructed 2m wide footway.
2. The visibility of the pedestrian crossing will be greatly improved for approaching vehicles, to conform to DMRB standard.
3. The visibility of approaching vehicles will be greatly improved for pedestrians waiting to cross, to conform to DMRB standard.
4. The on-going damage that roots are causing to the footway, carriageway and utilities in the area and subsequent maintenance issues is removed.
5. The risk of roots damaging the wall at the adjacent property and subsequent maintenance issues is removed.
6. The risk of a claim for damages (to a person tripping or property damage) as a result of the
